# In-situ Isolation of Contaminated Sediments: Case Studies and Best Practice

Karl Gustavson

U.S. Environmental Protection Agency

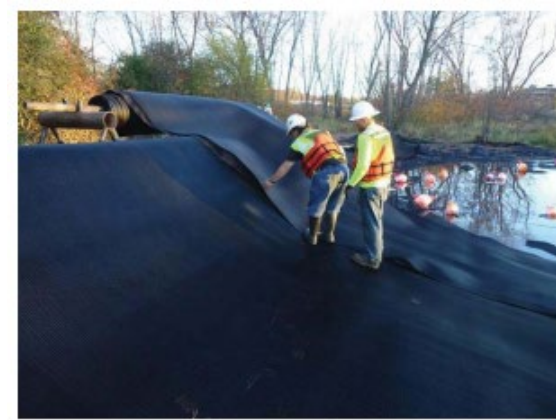
# Pine Street Canal (Vermont)

- **Canal capping** was completed in March 2003.
- In 2003, a NAPL breakout was discovered in an uncapped area immediately adjacent to, but not in, the canal.
- In 2004, **the sand cap was extended over a portion of the bank** where NAPL was being released.
- Later, NAPL was found on the surface water migration through the sand cap, primarily via gas bubbles.
- In 2010, **an amended cap was constructed** at the southern end of the canal to capture the NAPL before it is released. (“Over time the new cap will fill up and have to be replaced.”)
- To extend the life of the new cap (and prevent contamination from migrating into the canal), several **passive recovery wells were installed** along the banks of the canal.

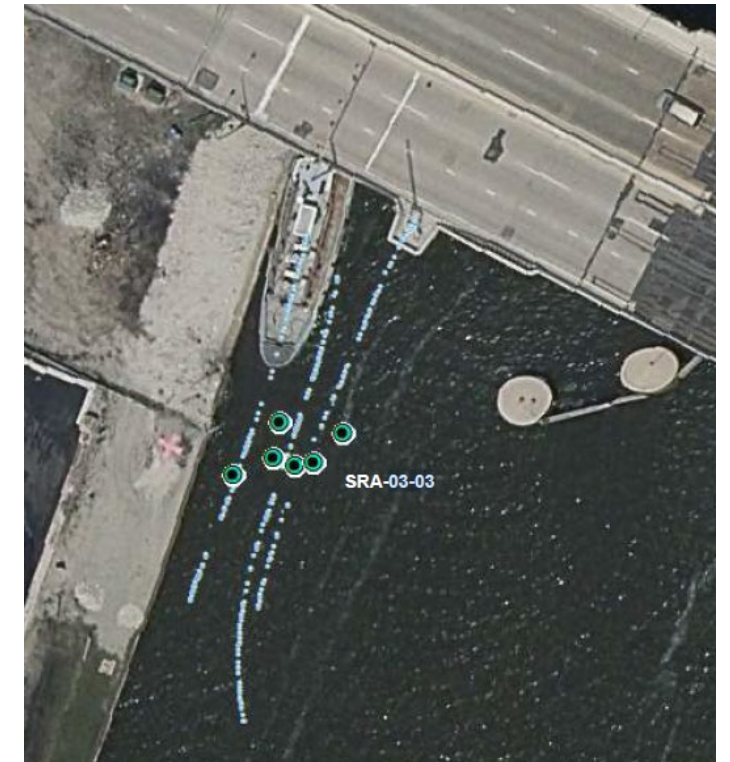
# Lower Fox River

- Routine and flood event-based bathymetry; poling/probing surveys to confirm armor layer and depth of sediment deposition.
- Poling/probing surveys indicate cap armor stone was present at all 490 poling locations providing and that cap armor layer coverage exceeds 95% over the caps.
- Surveys identified some areas of cap-induced settlement and some minor depressions likely primarily due to propwash. The amount of settlement observed in areas of cap-induced settlement did not exceed the range predicted during the design.

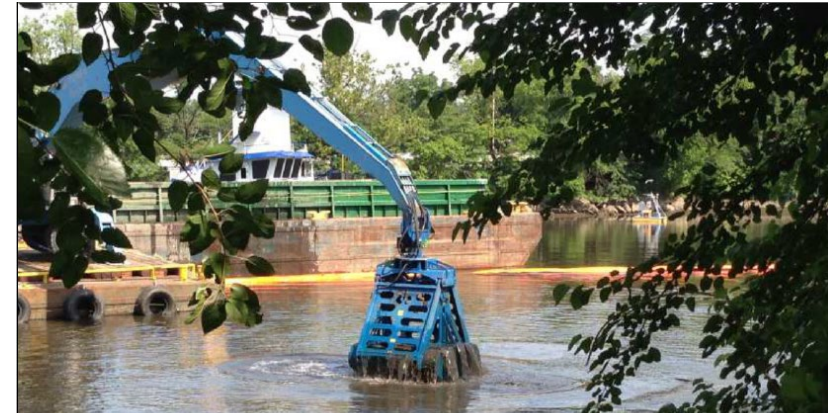
Sand/Habitat Layer  
12 inch Type A ( $D_{50} = 4.5$  inches)  
Armor Layer  
Geotextile  
10 inch Sand/Active Layer  
Underlying Sediment  
(Post Dredge)

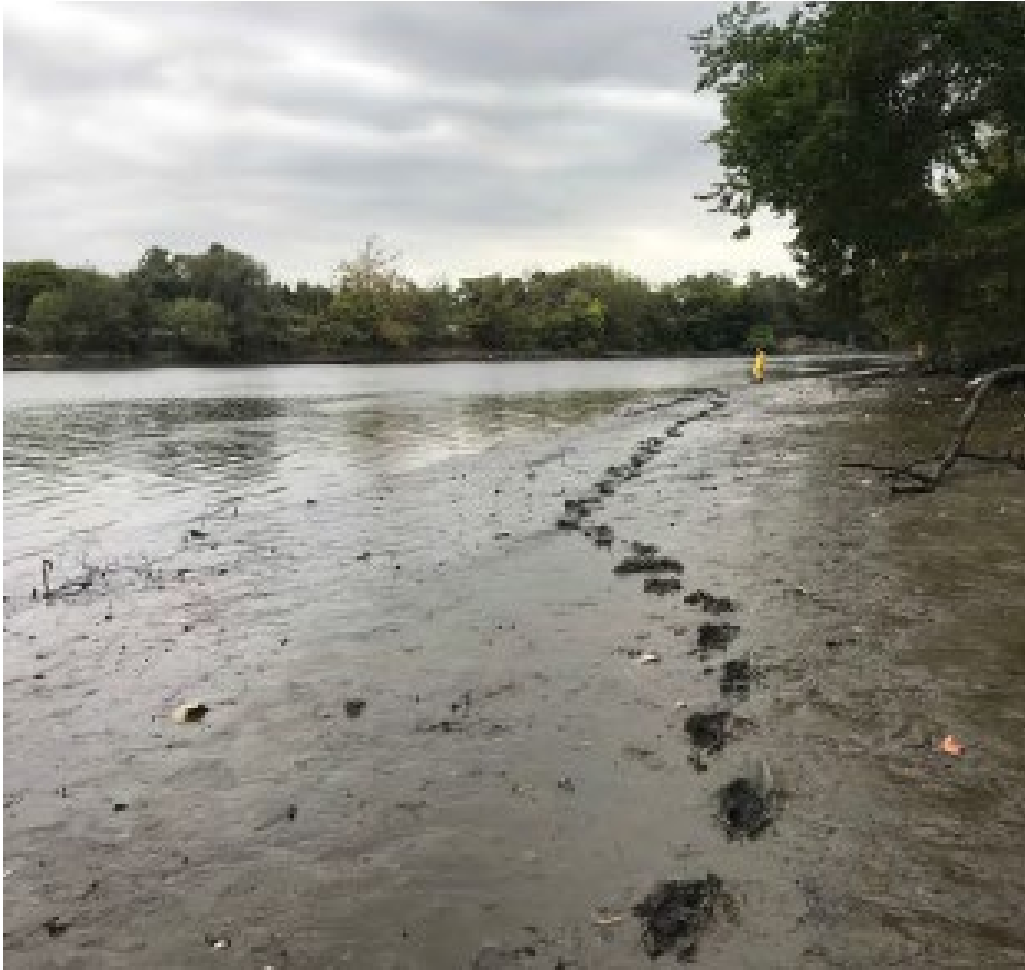
# Passaic River, NJ RM 10.9 TCRA Cap

- Bathymetry, LIDAR, and poling to determine cap elevation
- Deposition on top of cap following placement; some indication of settling

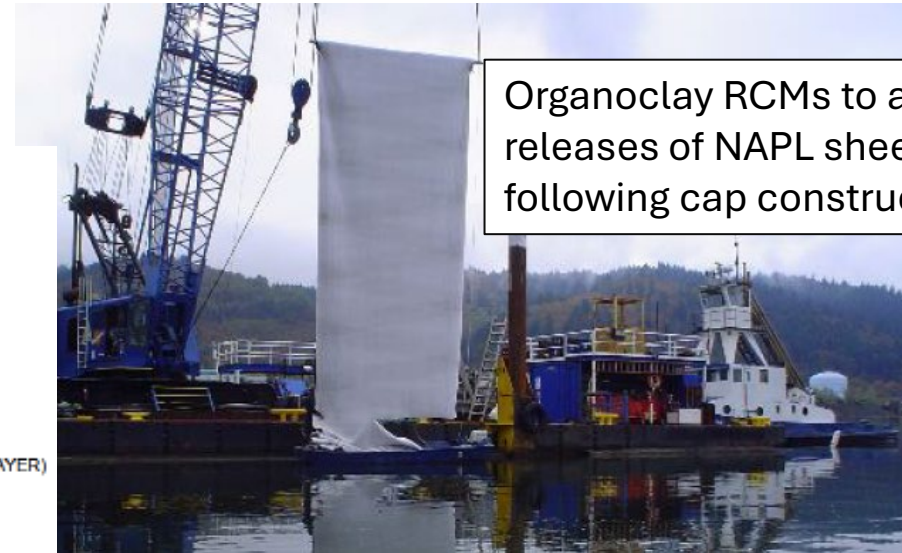
Organoclay RCMs to address releases of NAPL sheens discovered following cap construction in 2004.

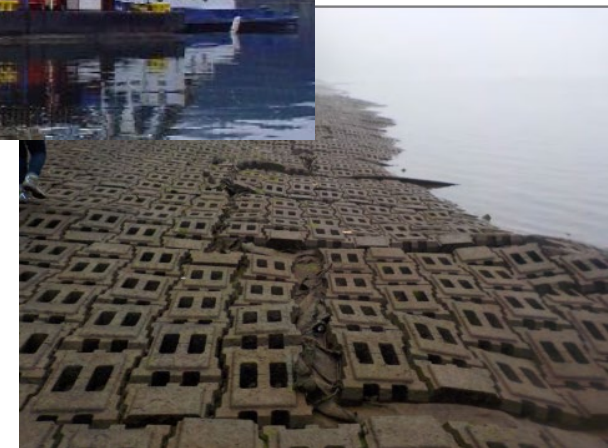
## BATHYMETRY DIFFERENCE 2006 VS. 2018 (FEET)

- BOULDER CLUSTERS/ROCK MOUND
- RIPRAP ARMOR
- GRANULAR ORGANOCLAY
- ORGANOCLAY MAT (DOUBLE LAYER)
- ORGANOCLAY MAT (SINGLE LAYER)
- HOT SPOT TREATMENT (THICKENED SAND LAYER)
- ARTICULATED CONCRETE BLOCK
- 6-INCH MINUS ROCK ARMOR
- 10-INCH MINUS ROCK ARMOR
- TURF REINFORCEMENT MAT OVER EARTHEN CAP
- EARTHEN SOIL CAP BOUNDARY
- SUBSURFACE BARRIER WALL
- SEDIMENT CAP BOUNDARY
- IMPERMEABLE CAP

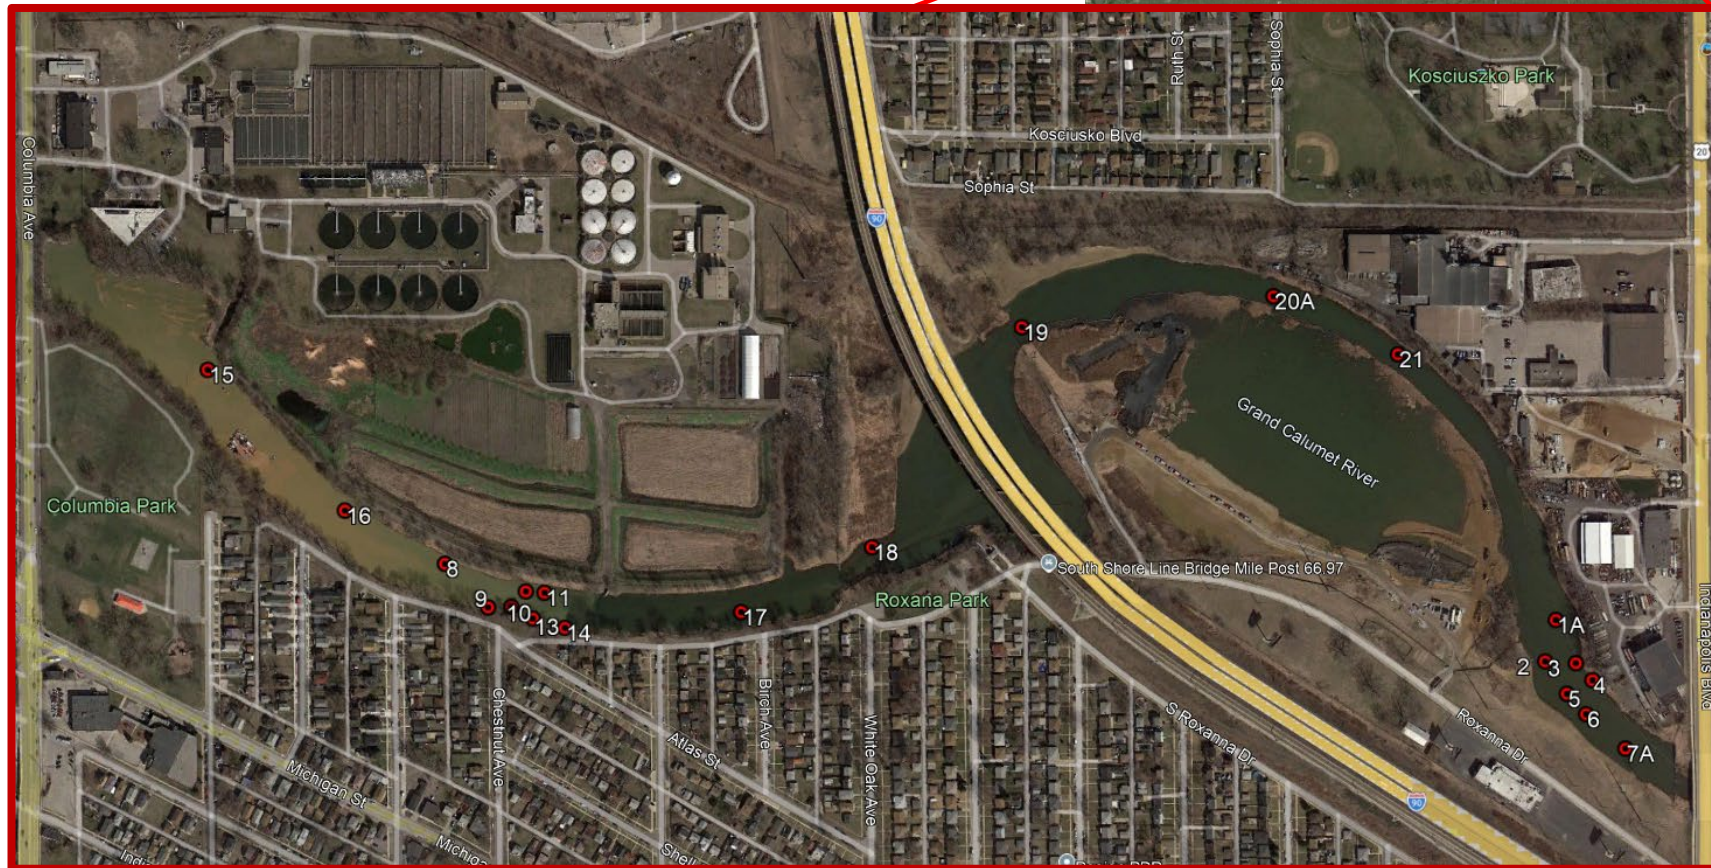
# West Branch Grand Calumet River

- 1.2 river miles, relatively shallow and low gradient
- Impacted by NAPL/PAHs from historic industrial discharges

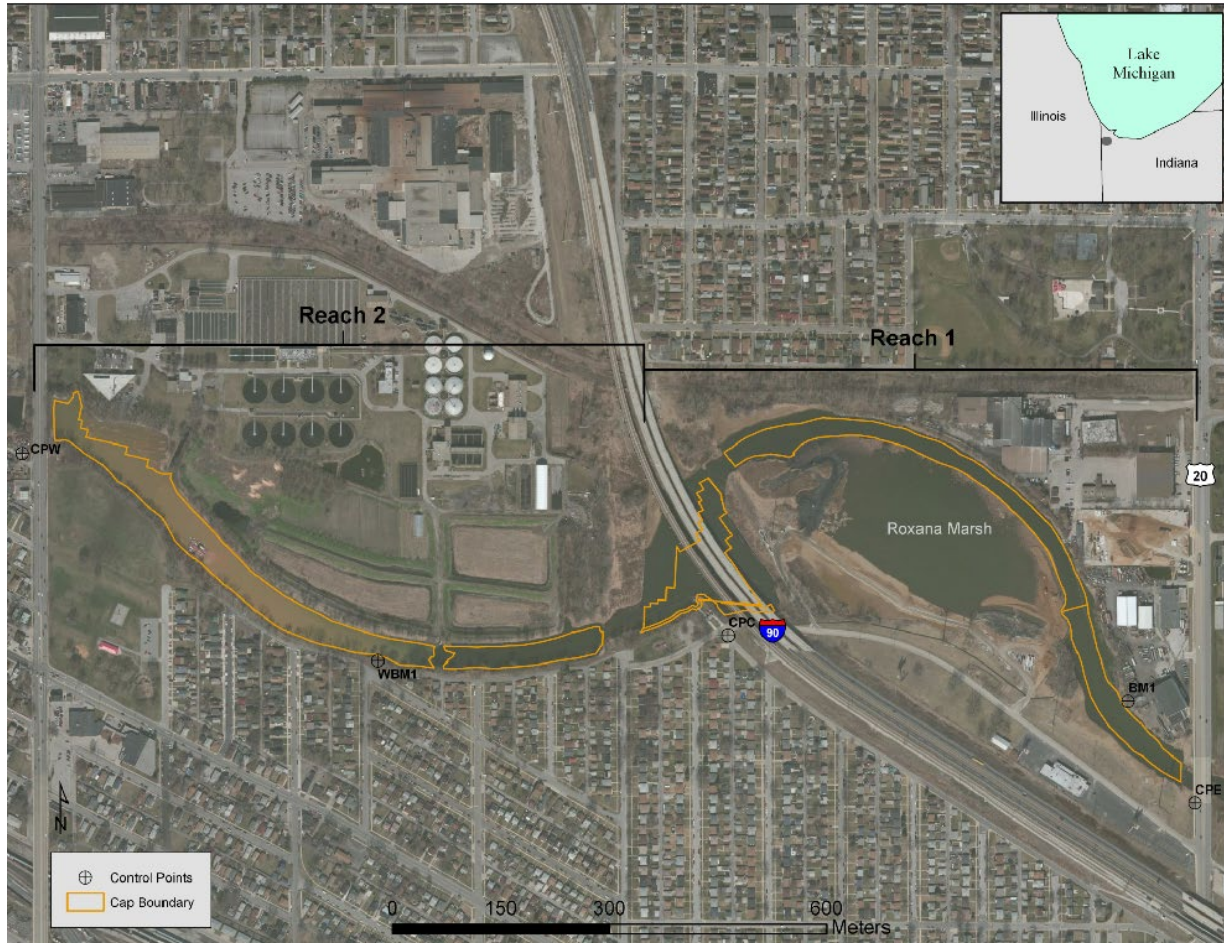
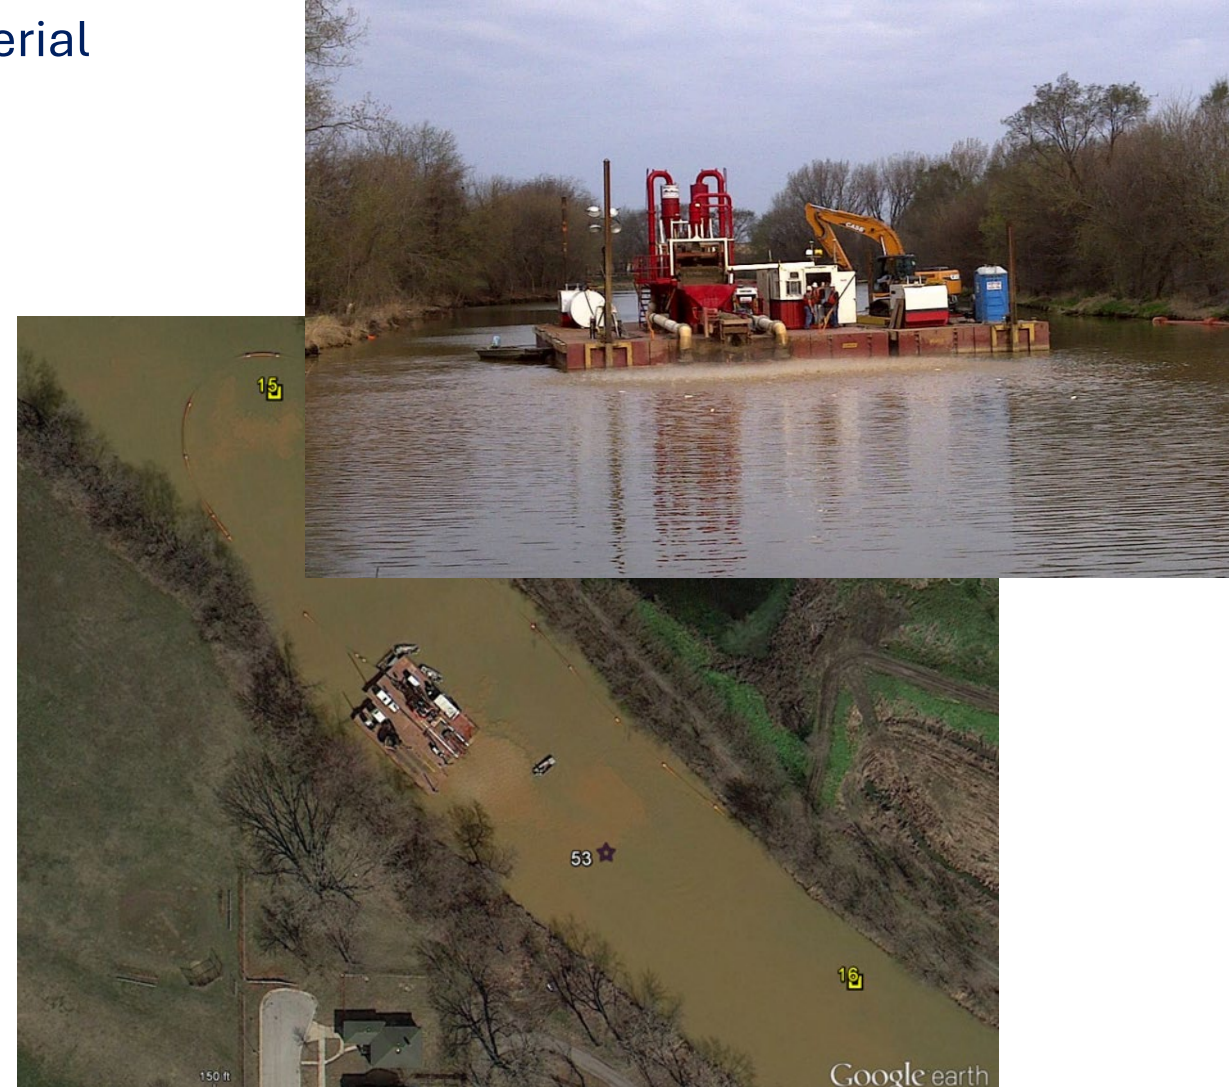
# West Branch Grand Calumet River

- Hydraulic dredging of top 2-3 ft of sediment
- -Isolation cap: 6 in. of organoclay and granular material below 12 in. of granular material
